**CWA COMPLIANCE EVALUATION INSPECTION REPORT
U.S. ENVIRONMENTAL PROTECTION AGENCY, REGION 5**

Compliance Evaluation Sampling Inspection

Sandway Farm, LLC

April 18, 2013

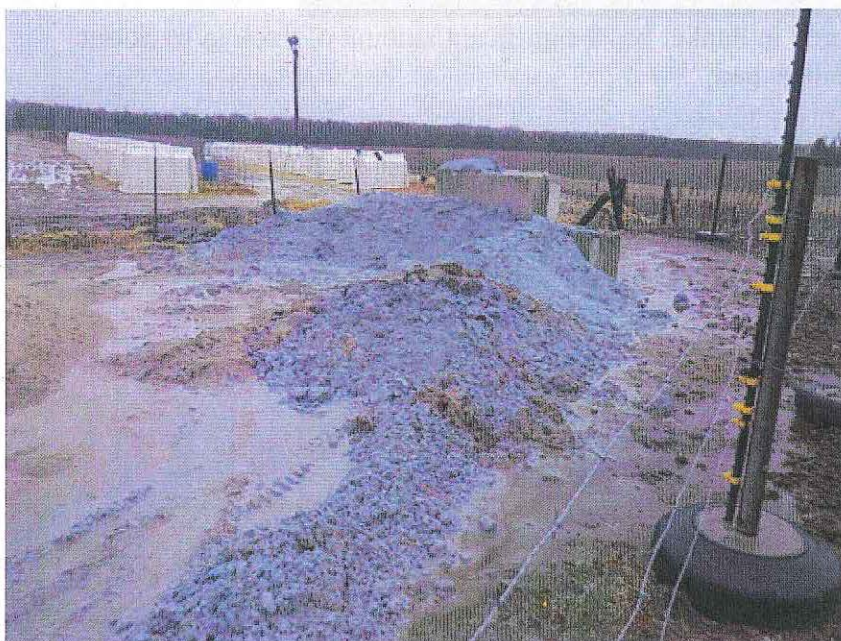
IMGP0050: Sandway utilizes a product made from pulverized newspaper as alternative bedding.

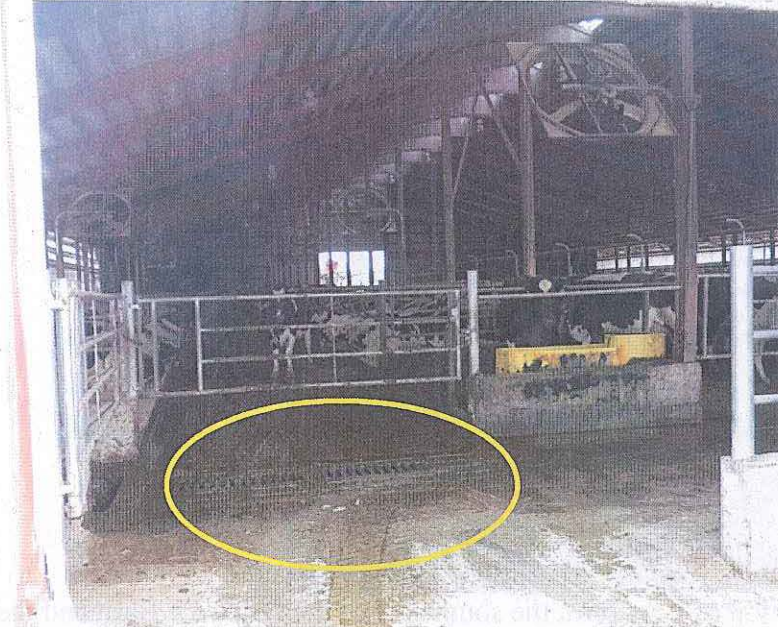
EPA also observed the collection channel for manure below the floor on the south side of Barn #2. Manure is scraped to a grate where it falls to the collection channel and then flows by gravity to a pit at the southeast corner of the barn. From here, the manure is pumped to the manure channel in the Main Barn.

IMGP0051: Inside Barn #2. Manure is manually scraped to grate in foreground where manure falls into a collection channel. The manure flows via gravity in the collection channel to a pit in the southeast corner of the barn. Yellow circle denotes location of the grate in the floor where manure is pushed into.

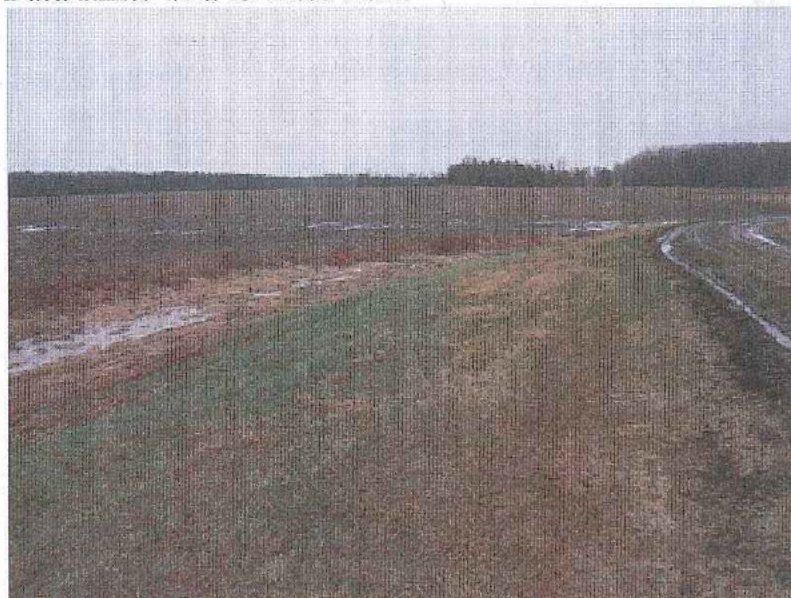
IMGP0087: East Ditch flows south on the east side of the facility.

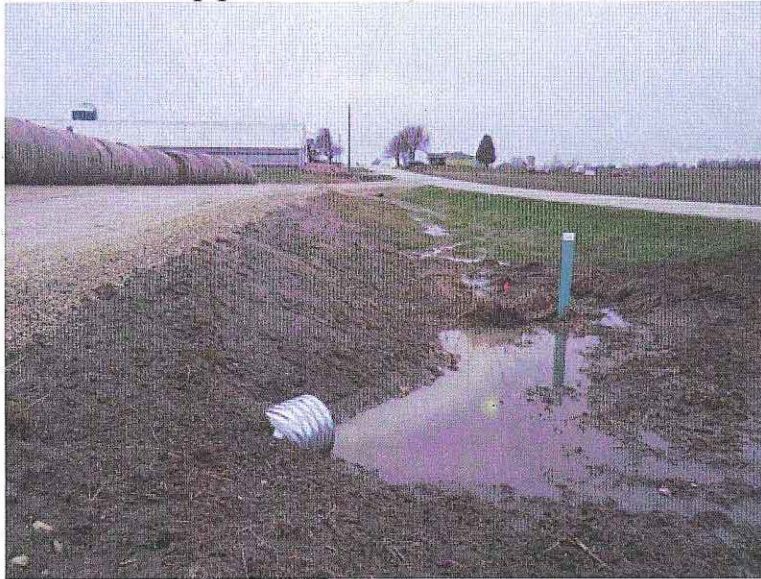
At the northeast corner of the facility, a culvert directed flow from a roadside ditch to the East Ditch. The culvert went under a facility driveway. Storm water also flows to the East Ditch via a pipe under Bolt Road from the north. A green standpipe indicated the location of the pipe under Bolt Road.

IMGP0089: Culvert accepts flow from the roadside ditch and directs it to the East Ditch that flows to the south along the east side of the facility. Green standpipe indicates location of pipe under Bolt Road.

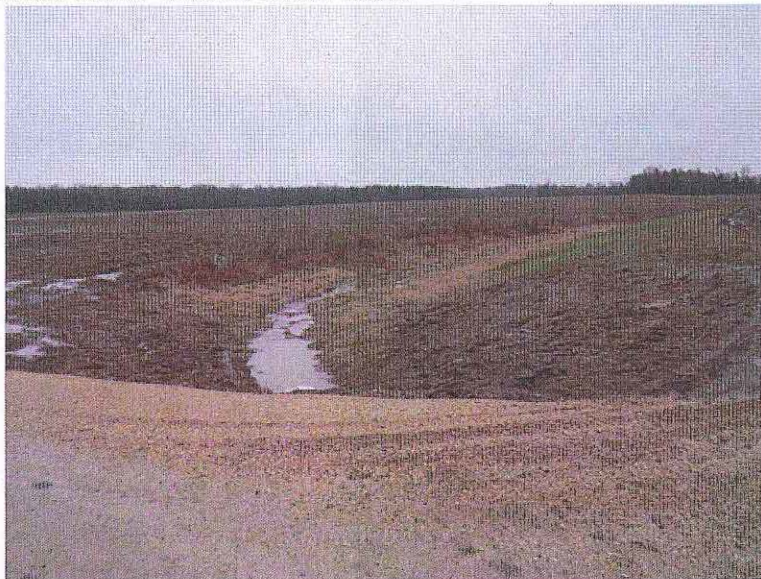
IMGP0090: Outlet of the culvert from roadside ditch flows under facility driveway.

Flow goes to the south in the East Ditch.

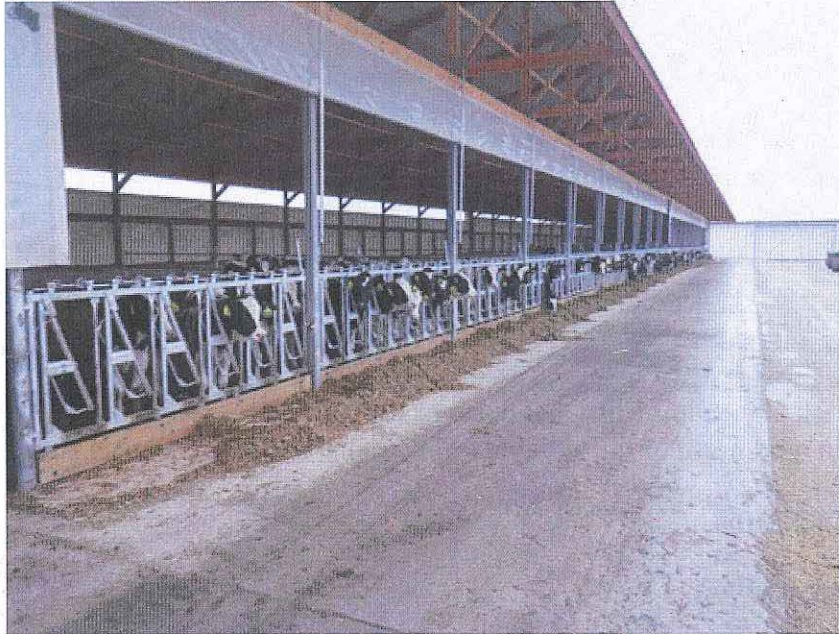
EPA walked east along the south side of the new Calf Barn which houses 136 calves. The roof overhangs the feed lane to prevent feed runoff. There are no gutters on the Calf Barn roof. Raw materials were stored in the west end of the barn and the load in door was on the east side. EPA did not observe any problems or issues with the Calf Barn on the day of the inspection.

IMGP0092: The new Calf Barn holds 136 calves.
Location: East of the 2nd Stage Manure Holding Pond
Facing: Northeast
Date/Time: 4/18/13 11:07 A.M.

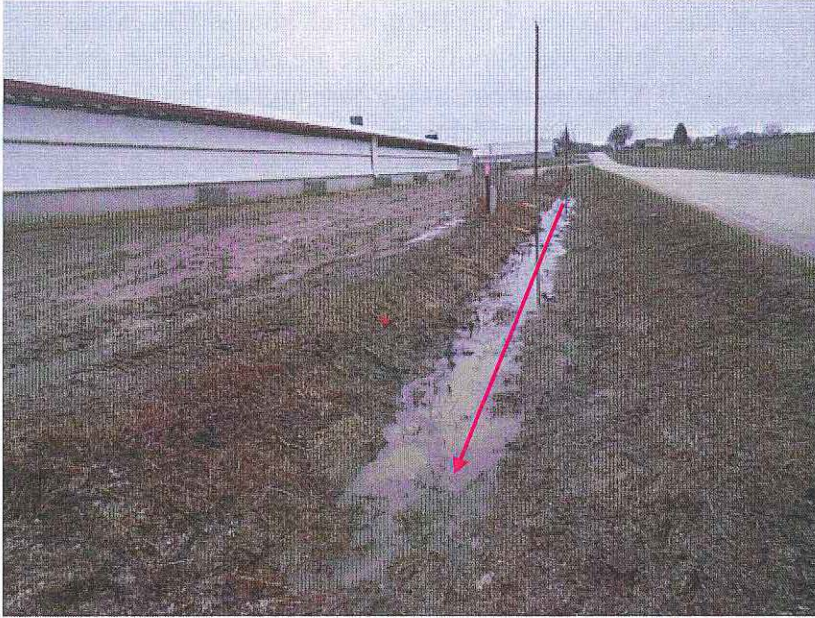
EPA walked west on the north side of the Calf Barn. The area north of the barn had not been seeded with vegetation yet. The roadside ditch flowed from west to east in front of the barn. There was water in the roadside ditch all the way to the Main Barn.

IMGP0096: Roadside ditch along Bolt Road and north of the Calf Barn. Vegetation hasn't been established in yard north of the barn yet. Flow in culvert is to the west, as indicated by the red arrow.

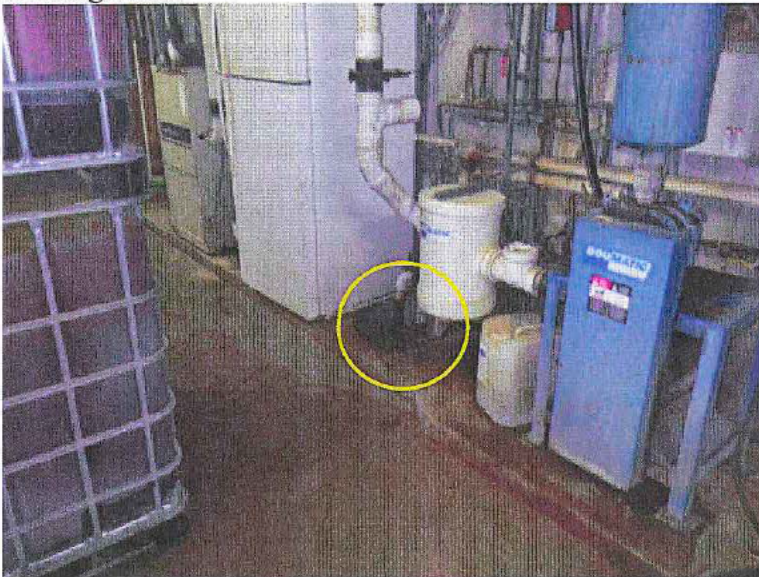
Milking Parlor wash water flows to a sump from where it is then pumped to the manure channel in the Main Barn. From there, it flows with the manure to the 1st Stage Manure Holding Pond.

IMGP0112: Inside the back of the Milking Parlor. Sump, next to refrigerator (circled with yellow circle), receives flow from Milking Parlor wash water.

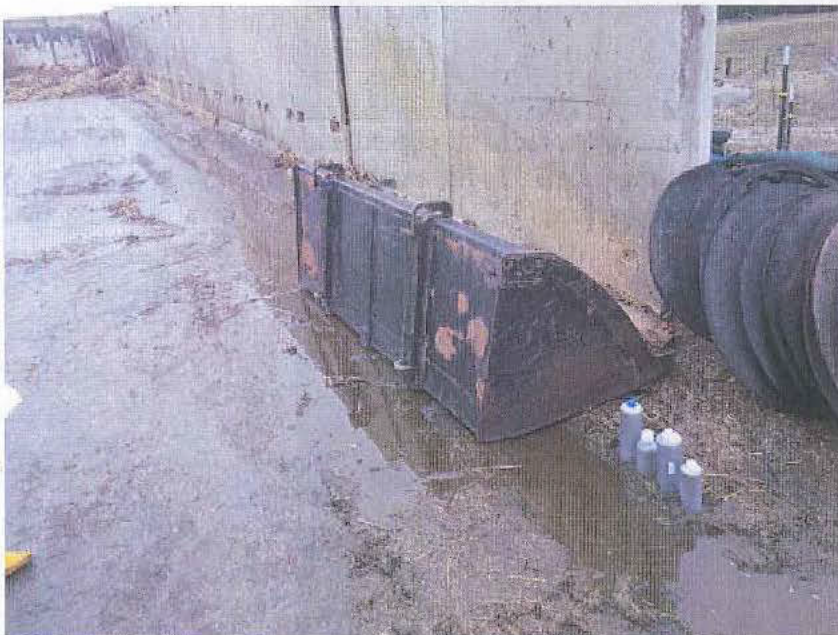
EPA prepared sample bottles then returned to take samples at Sandway and observe the confluences of the East Ditch and West Ditch with the perennial unnamed tributary. EPA took the first sample, S01, titled "Bunker", at 1:20 P.M. from the flow of leachate from the manure pile in the southernmost feed bunker. While EPA was preparing the bottles, the precipitation that had been occurring during the walk through of the facility had diminished. Also, [REDACTED] had deposited a pile of straw in the flow pathway from the manure pile. There was a flow of process wastewater from the manure pile.

IMGP0121: Sample #1, S01, "Bunker", was taken at 1:20 P.M. from the flow pathway from the manure that was stored in the feed bunker.

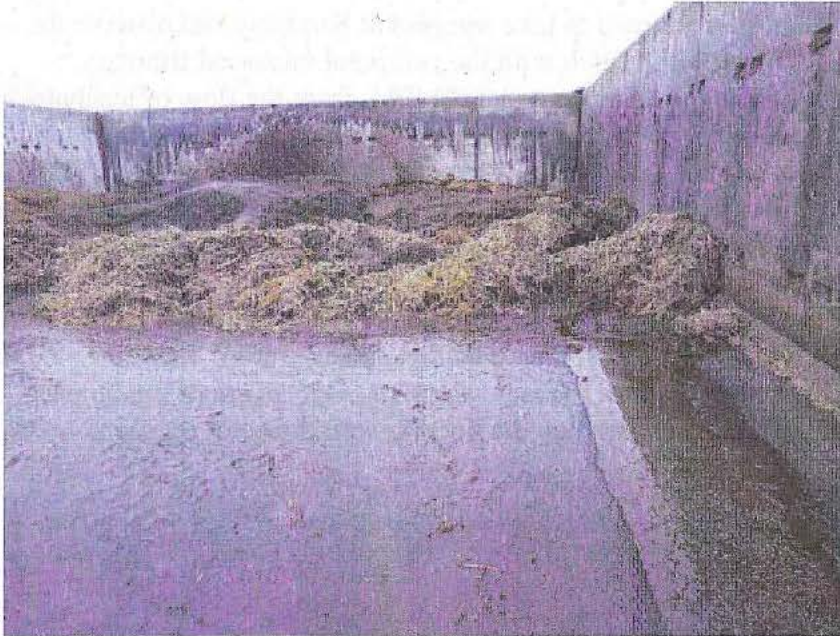
IMGP0122: By the time sampling started, the rain had ceased and some straw in the flow pathway from the manure in the bunker. Ex. 6 (Personal Privacy) had piled
 Location: Inside the southernmost feed bunker
 Facing: Southeast
 Date/Time: 4/18/13 1:22 P.M.

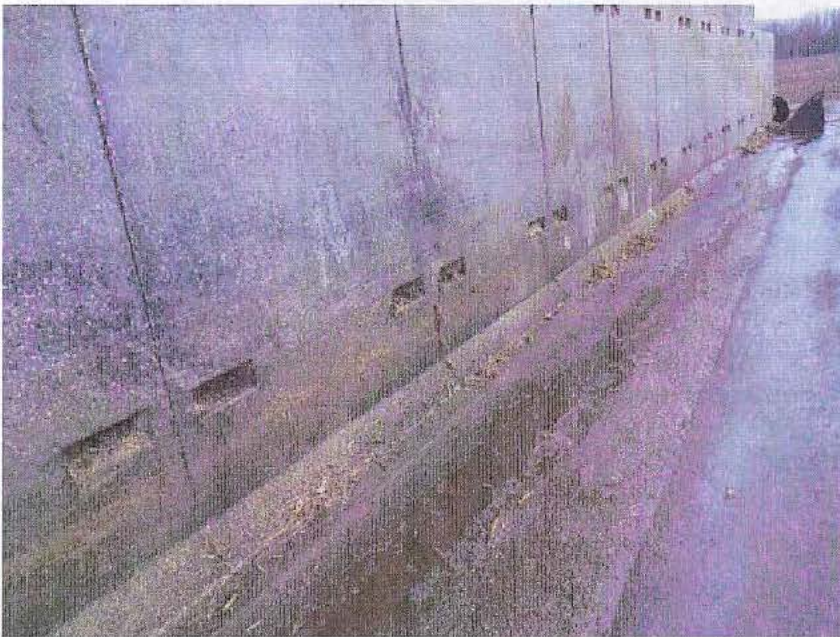
IMGP0123: Flow pathway off the manure stored in the feed bunker.
 Location: Inside the southernmost feed bunker
 Facing: West
 Date/Time: 4/18/13 1:22 P.M.

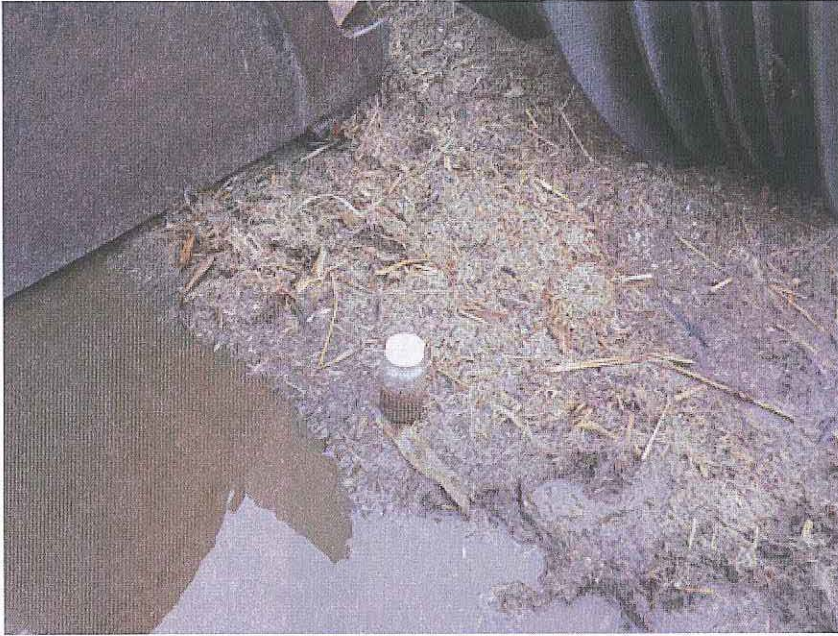
IMGP0124: Fecal coliform sample S01 "Bunker" was taken at 1:20 P.M. from flow pathway off the manure stored in the feed bunker.

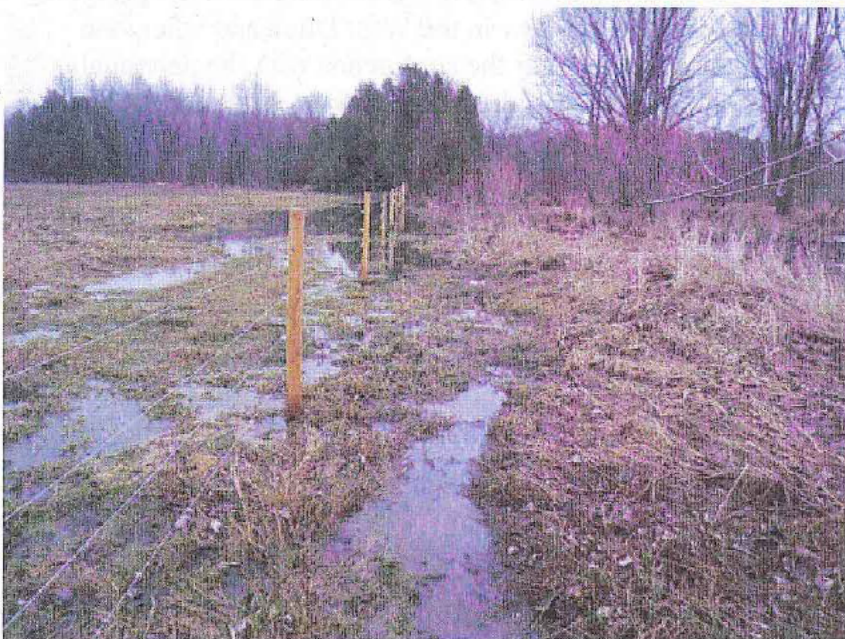
IMGP0131: West Ditch pools in the pathway.

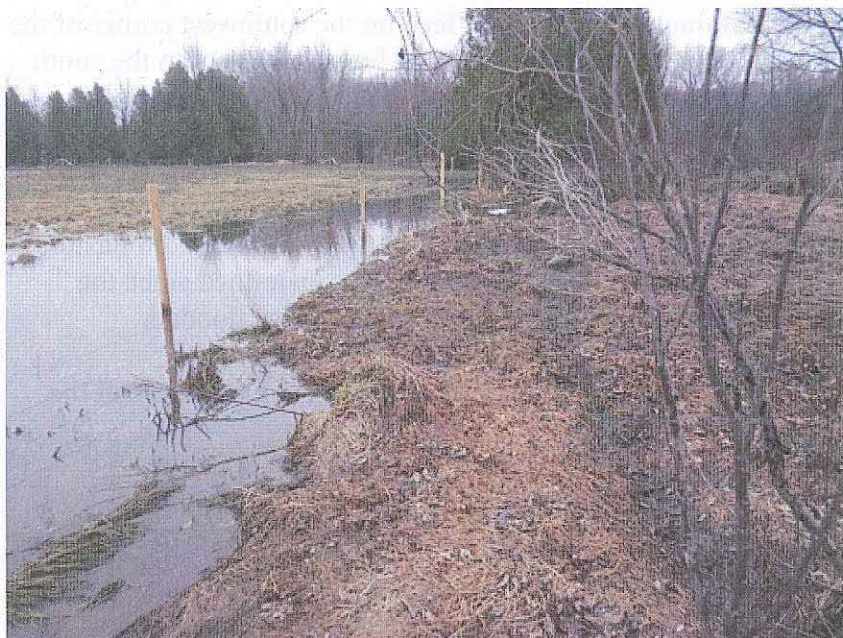
IMGP0134: West Ditch before the confluence with the perennial unnamed tributary.

Perennial unnamed tributary is in the tree line.

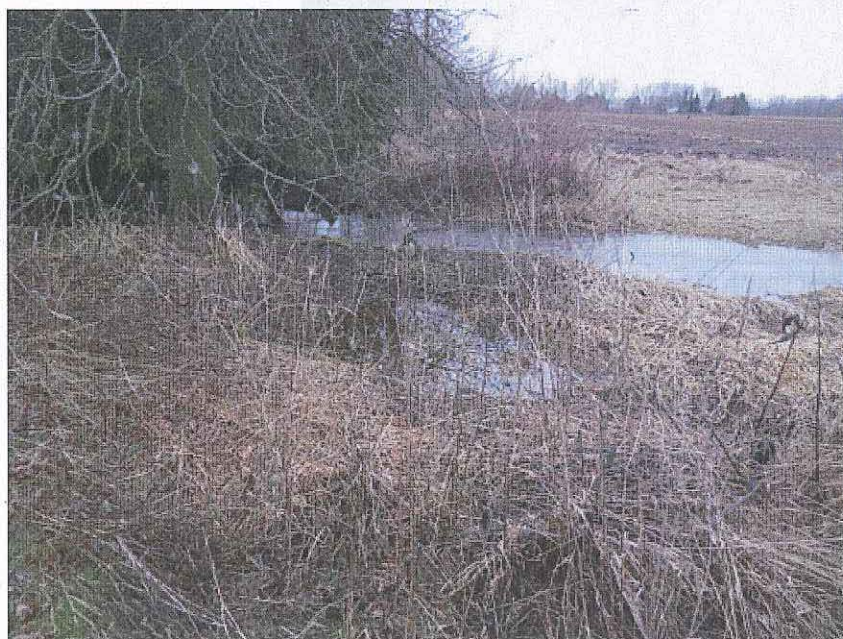
IMGP0138: Confluence of the West Ditch with the perennial unnamed tributary.

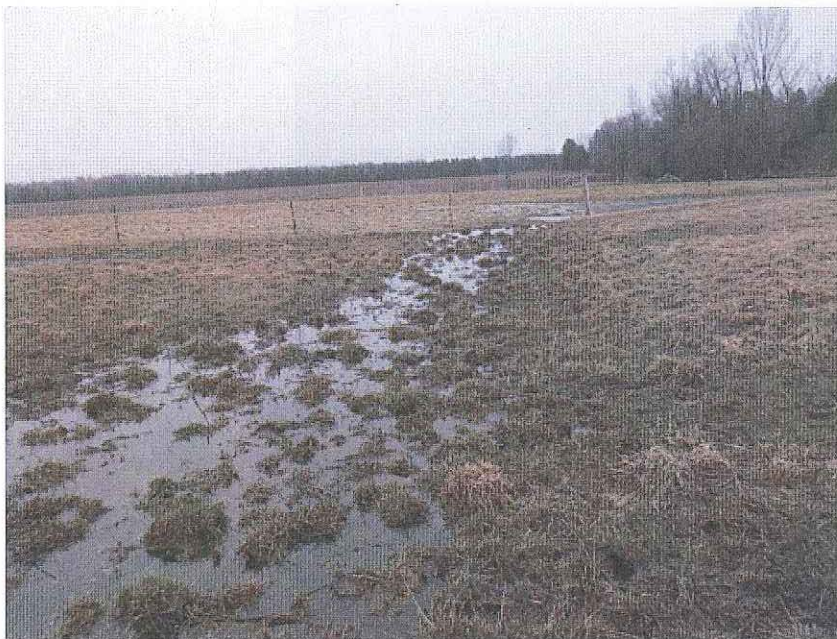
IMGP0145: The water pathway takes an easterly course through Pasture #1.

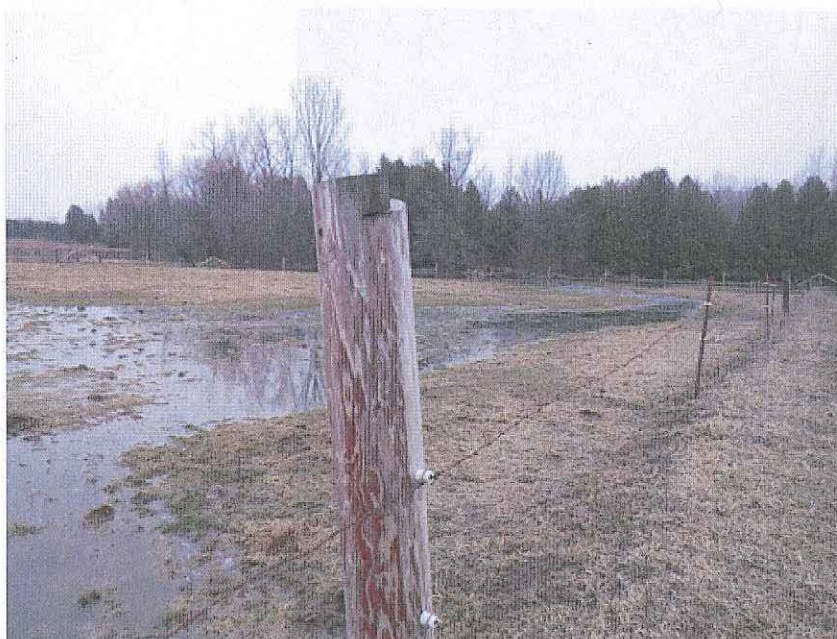
IMGP0147: The flow pathway leaves Pasture #1 and enters Pasture #2.

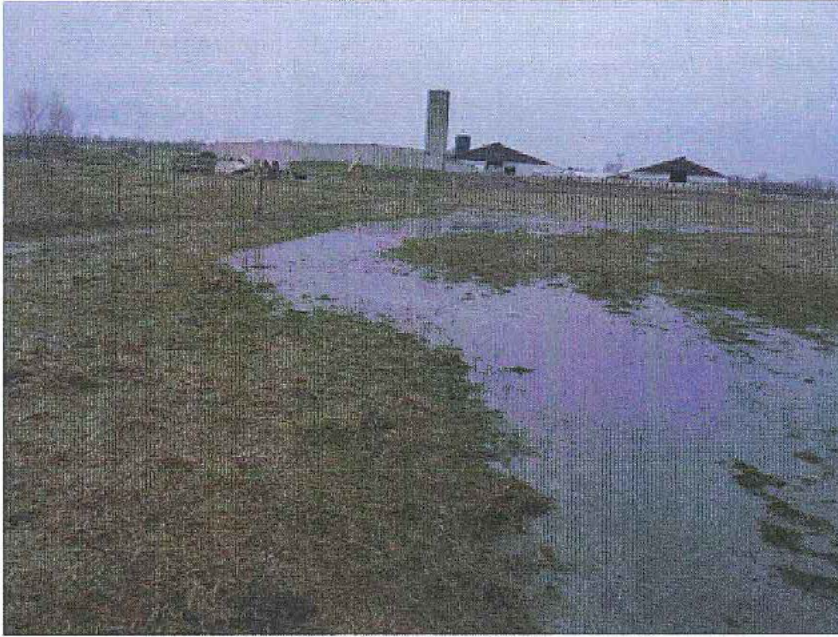
IMGP0149: Once in Pasture #2, the flow turns to the south.

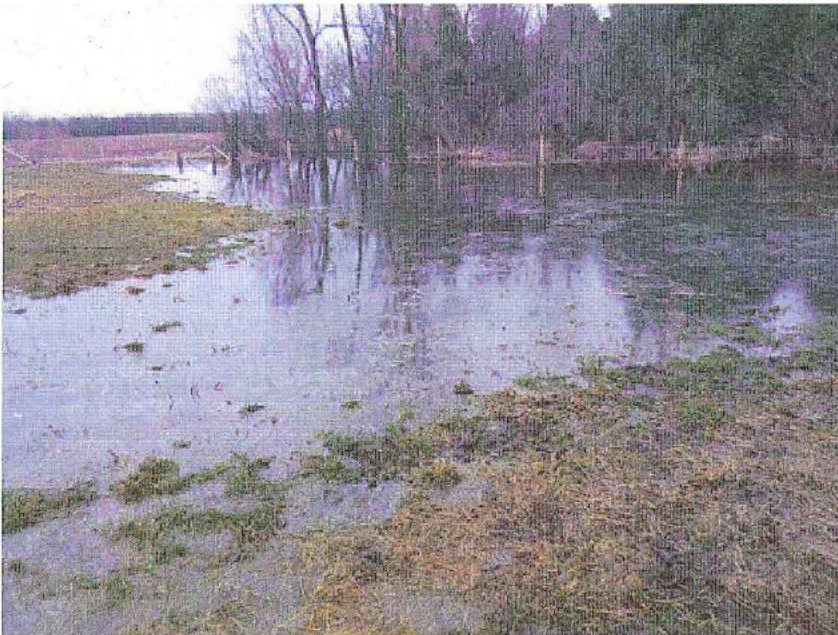
IMGP0150: Just north of the confluence of the flow pathway in Pasture #2 and the perennial unnamed tributary.

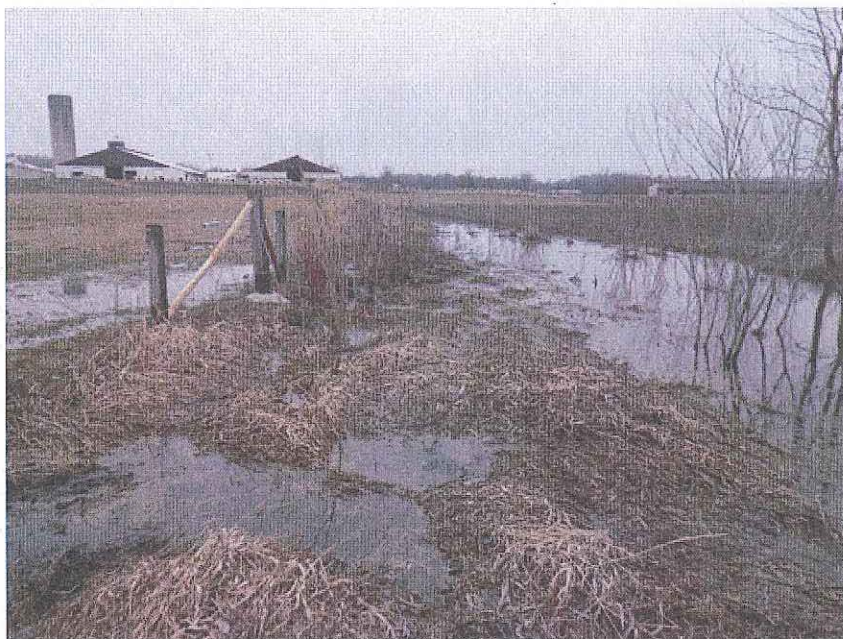
IMGP0151: Flow pathway from Pasture #2 is on the left side of the photo. On the right side is the East Ditch.

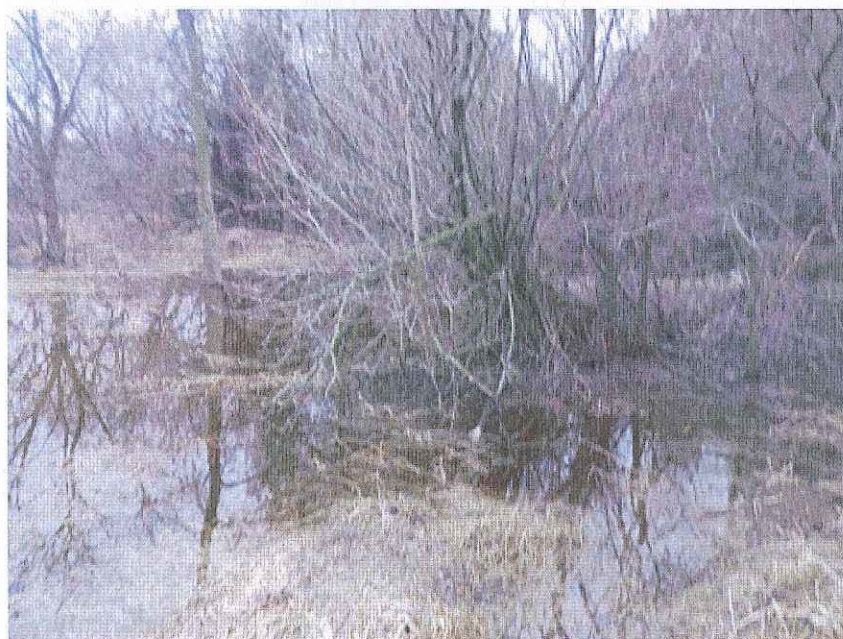
IMGP0152: Confluence of flow pathways with perennial unnamed tributary.

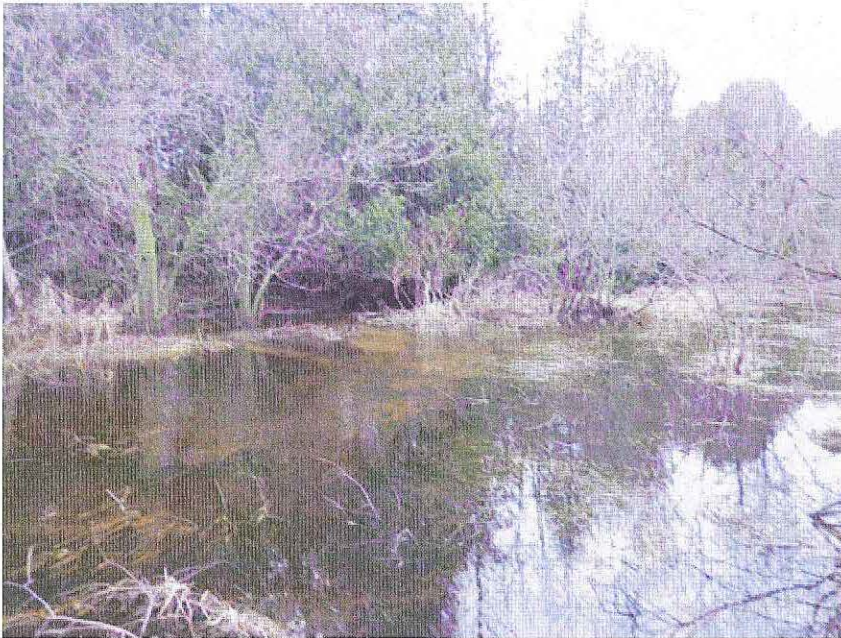
IMGP0156: The regular channel of the perennial unnamed tributary is in the tree line.

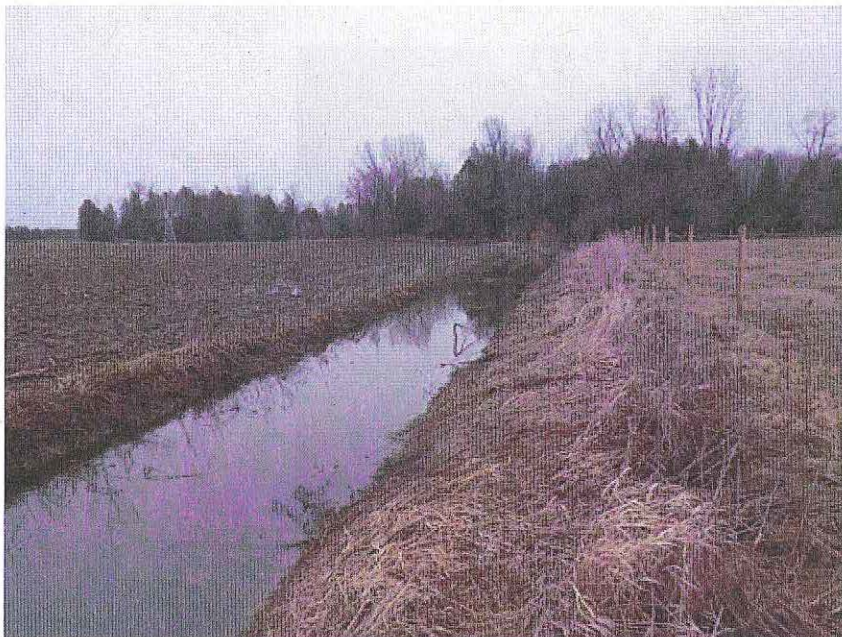
IMGP0158: East Ditch is well defined on the east side of Pasture #2. Fence delineates the eastern edge of Pasture #2.

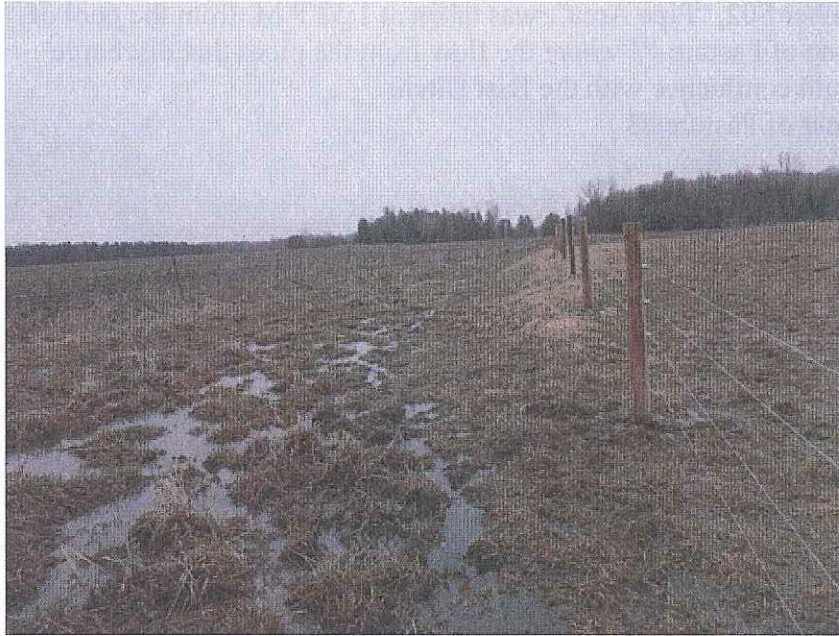
IMGP0168: Looking downstream at the East Ditch as it flows south along the east side of Pasture #3.

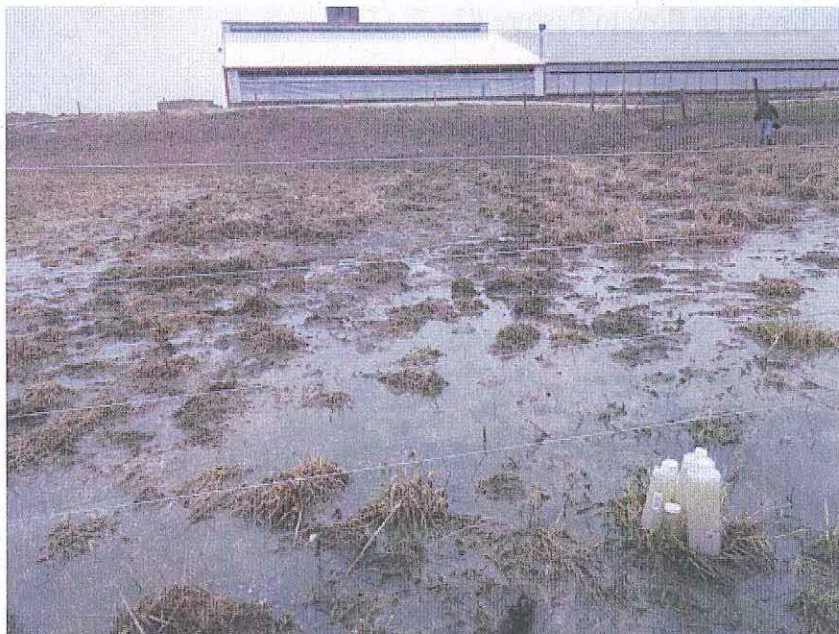
At the northeast corner of Pasture #3, EPA observed the flow pathways coming from the white pipes in the hillside in the northwest corner of Pasture #3. EPA took sample number S02, named "Pipe Area", at 1:52 P.M. from the pool of water at the east fence line of Pasture #3 where the flow from the pipes that discharge flow into Pasture #3 would confluence with the East Ditch.

IMGP0170: Sample number S02, "Pipe Area", was taken at 1:52 P.M. from the pool of water at the east fence line of Pasture #3 where the flow from the pipes that discharge flow into Pasture #3 would confluence with the East Ditch.

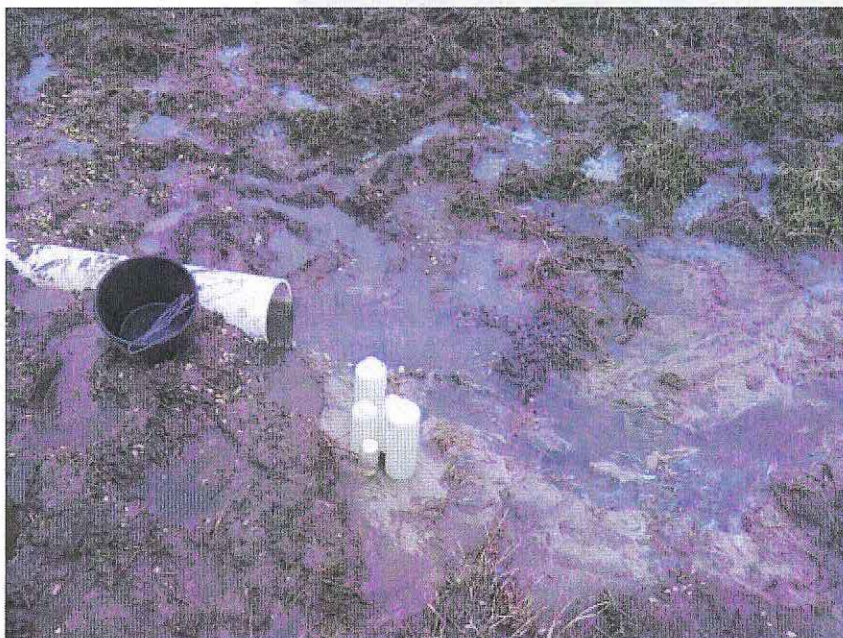
EPA went to the pipe outlets and observed that one of the pipes had liquid flowing from it. EPA took sample S03, named "North Pipe", at 2:03 P.M. from the northernmost pipe of the two pipes that discharge flow to Pasture #3.

IMGP0171: Sample S03, "North Pipe", was taken at 2:03 P.M. from the northernmost pipe of the two pipes that discharge flow to Pasture #3.

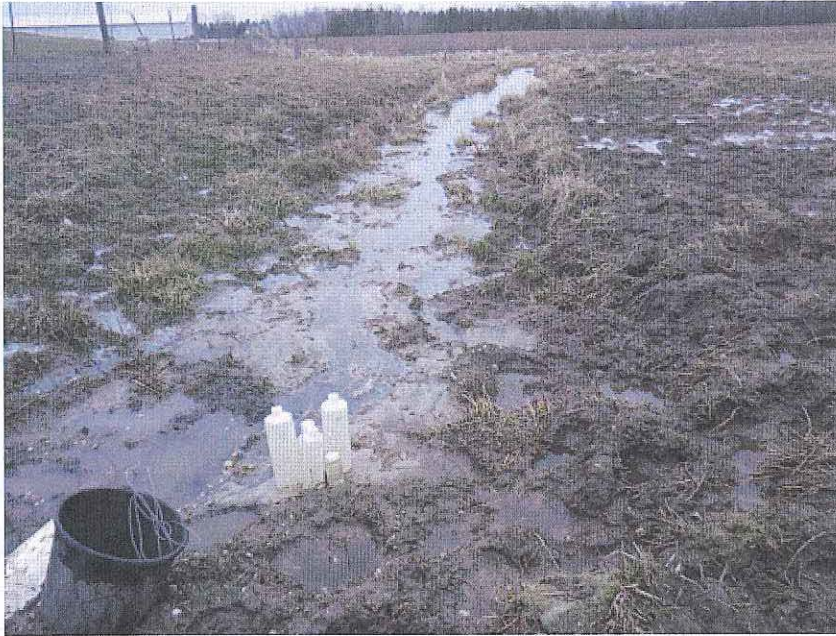
IMGP0172: Sample S03, "North Pipe", was taken at 2:03 P.M. from the flow from the northernmost pipe of the two pipes that discharge flow to Pasture #3.
